# Monastery of the Visitation of Holy Mary

378 Leighton Terrace

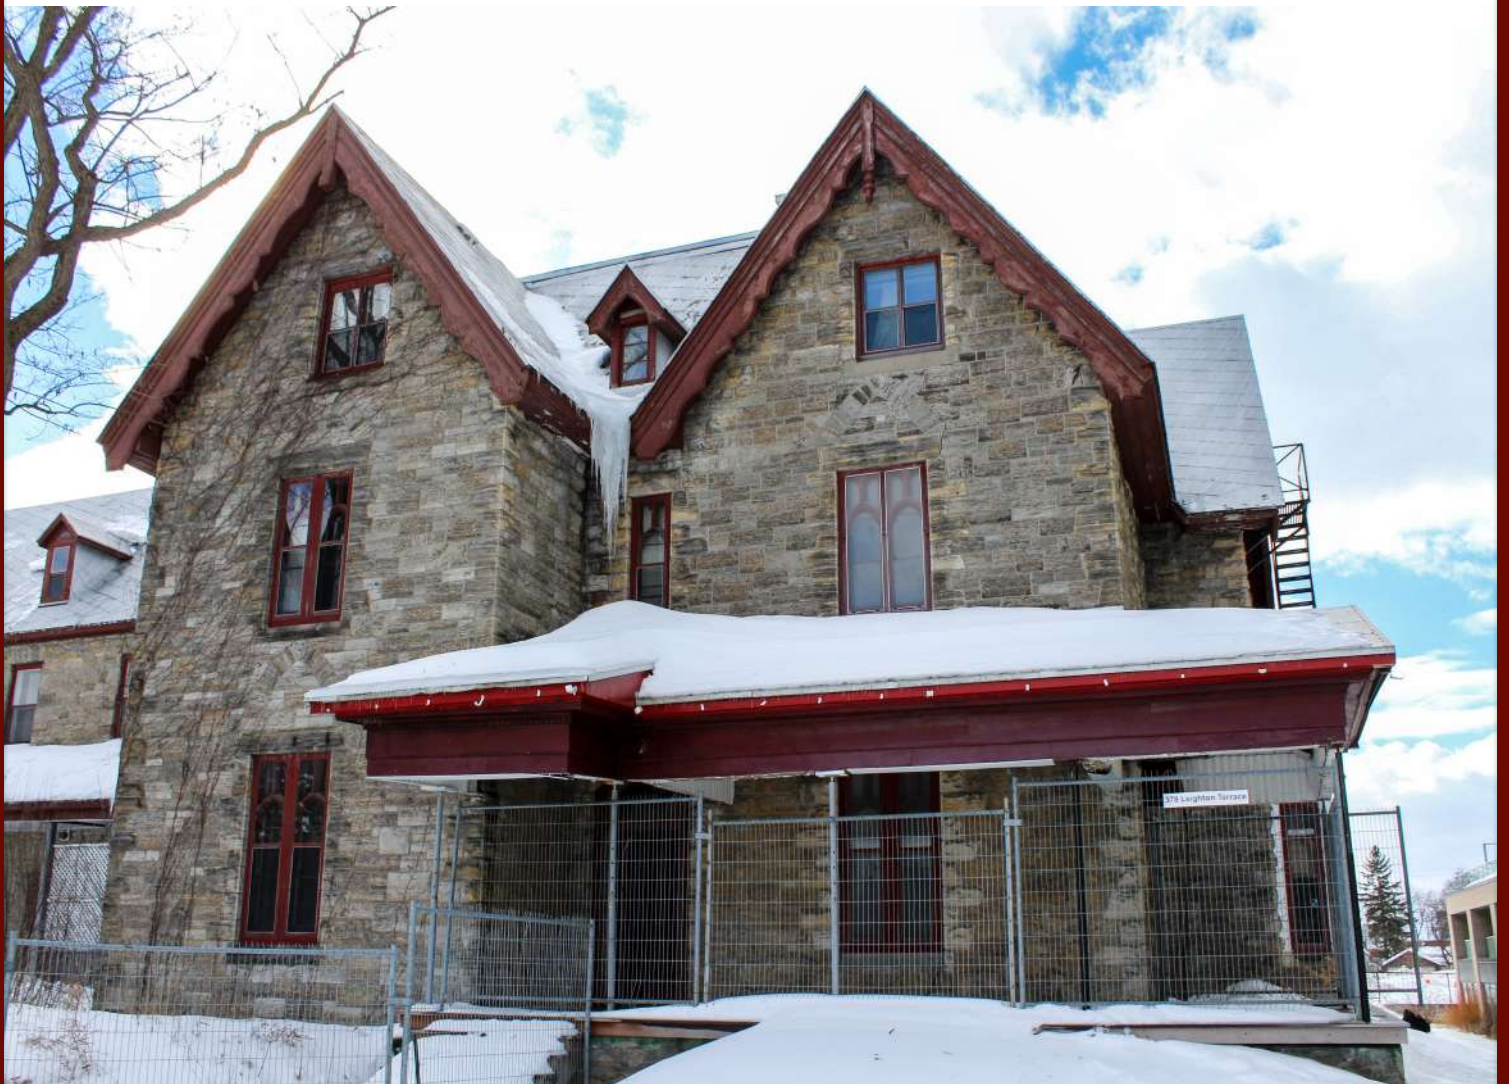
## Table of Contents

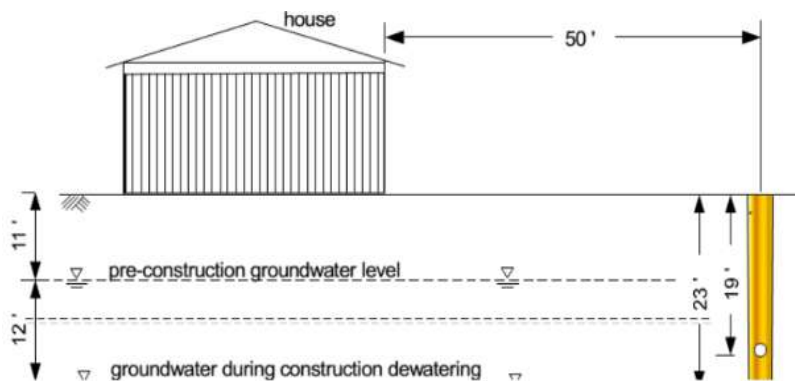
Figure 3.1.3: Dewatering Technique [5]

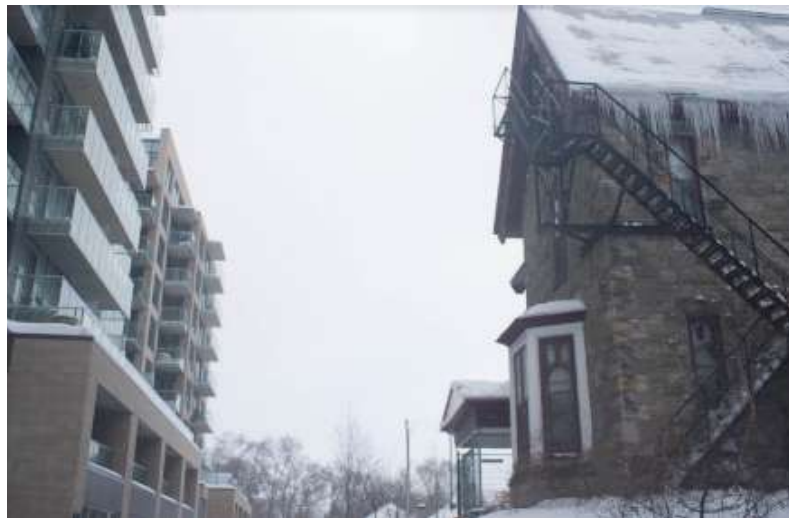
**Figure 3.1.4:** Wind Effect on Monastery

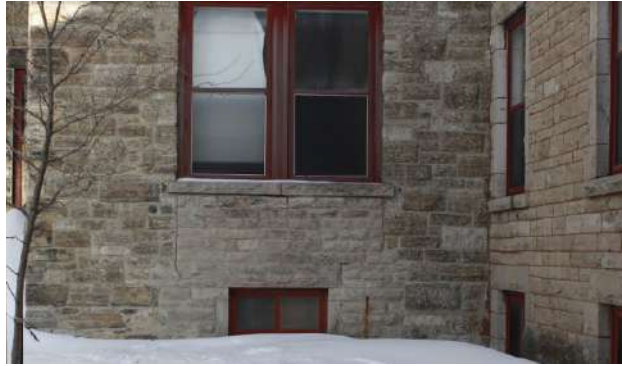
**Figure 3.2.1:** The Elms West Façade

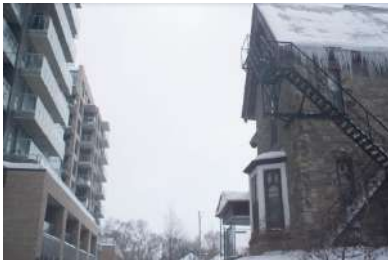
C1: View facing entrance to site. Monastery of the Visitation of Holy Mary. Renee. Carleton University. 11-04-2019

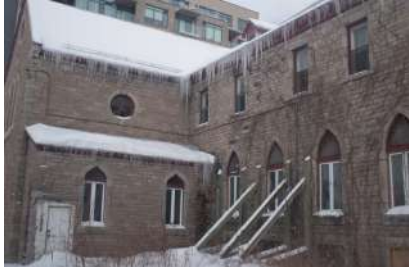
C3: View facing South-West façade. Monastery of the Visitation of Holy Mary. Renee. Carleton University. 11-04-2019

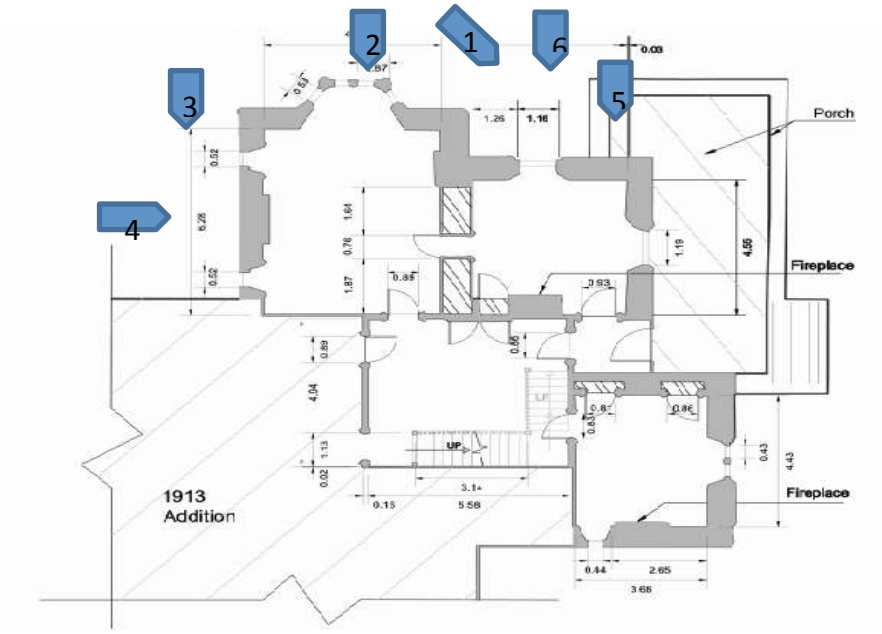
**Exterior Condition - Elms**

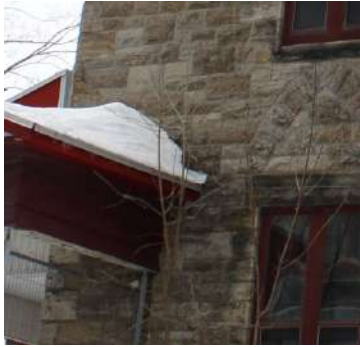
E1: Moisture Staining Elms.  
Monastery of the Visitation  
of Holy Mary. Tom. Carleton  
University. 11-04-2019

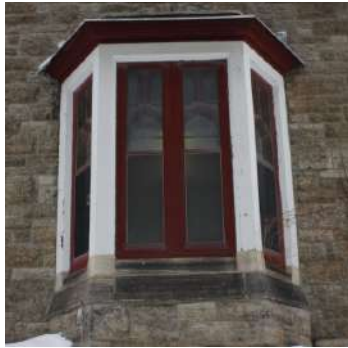
E2: Moisture Staining Elms.  
Monastery of the Visitation  
of Holy Mary. Tom. Carleton  
University. 11-04-2019

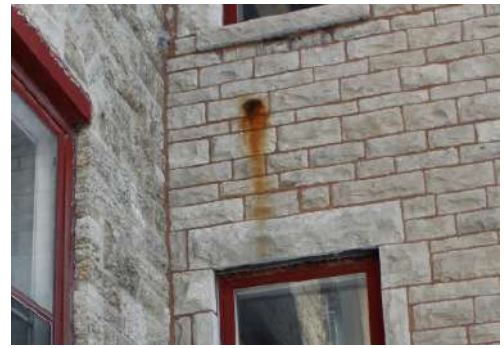
E3: Ferric Staining.  
Monastery of the Visitation  
of Holy Mary. Tom. Carleton  
University. 11-04-2019

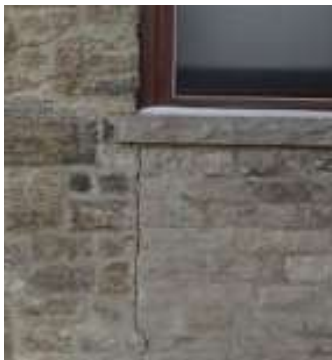
E4: Vertical Crack.  
Monastery of the Visitation  
of Holy Mary. Tom. Carleton  
University. 11-04-2019

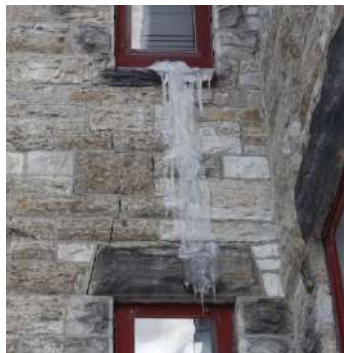
E5: Crack at Lintel.  
Monastery of the Visitation  
of Holy Mary. Tom. Carleton  
University. 11-04-2019

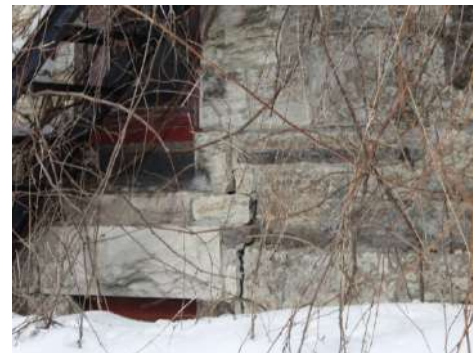
E6: Crack at Lintel.  
Monastery of the Visitation  
of Holy Mary. Tom. Carleton  
University. 11-04-2019

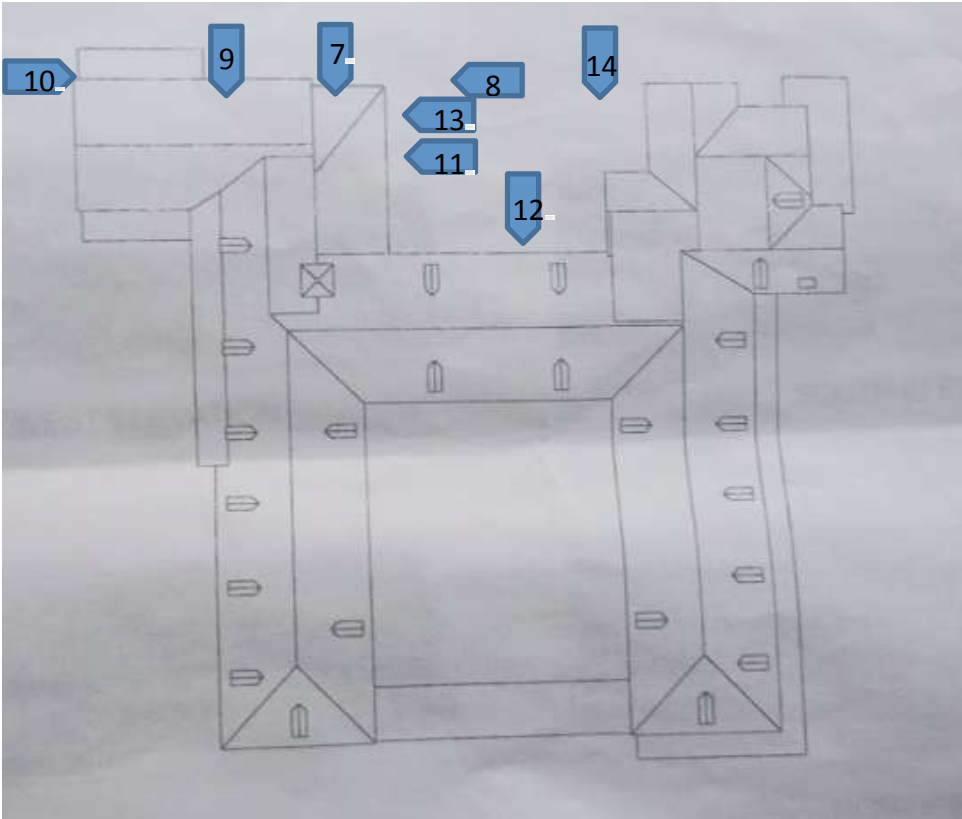
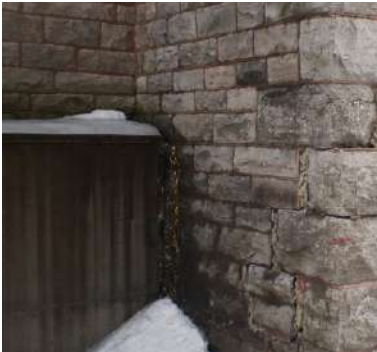
E7: Moisture Staining North Wall. Monastery of the Visitation of Holy Mary. Renee. Carleton University. 11-04-2019

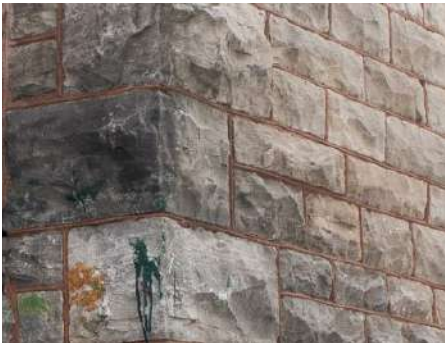
E8: Moisture Staining North Wall. Monastery of the Visitation of Holy Mary. Renee. Carleton University. 11-04-2019

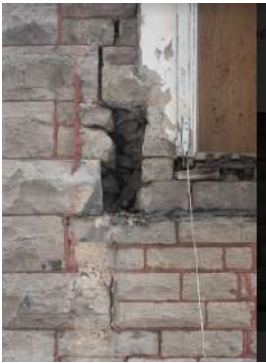
E9: Detached Fragment. Monastery of the Visitation of Holy Mary. Renee. Carleton University. 11-04-2019

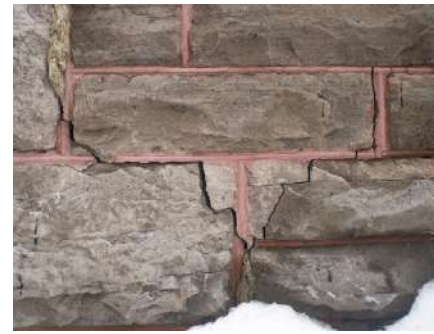
E12: Masonry Cracks.  
Monastery of the Visitation  
of Holy Mary. Renee.  
Carleton University. 11-04-  
2019

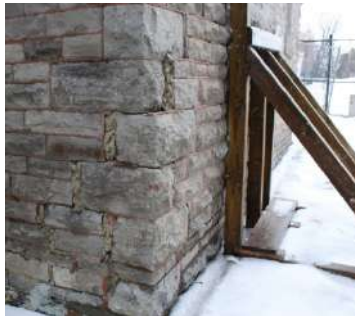
E13: Bulging Wall.  
Monastery of the Visitation  
of Holy Mary. Jason.  
Carleton University. 11-04-  
2019

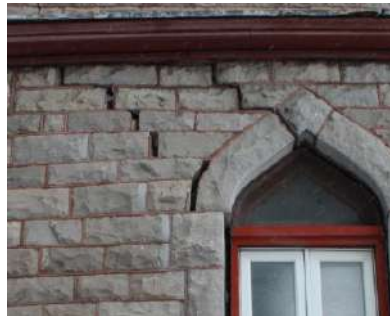
E14: Cracks near lintel.  
Monastery of the Visitation  
of Holy Mary. Jason.  
Carleton University. 11-04-  
2019

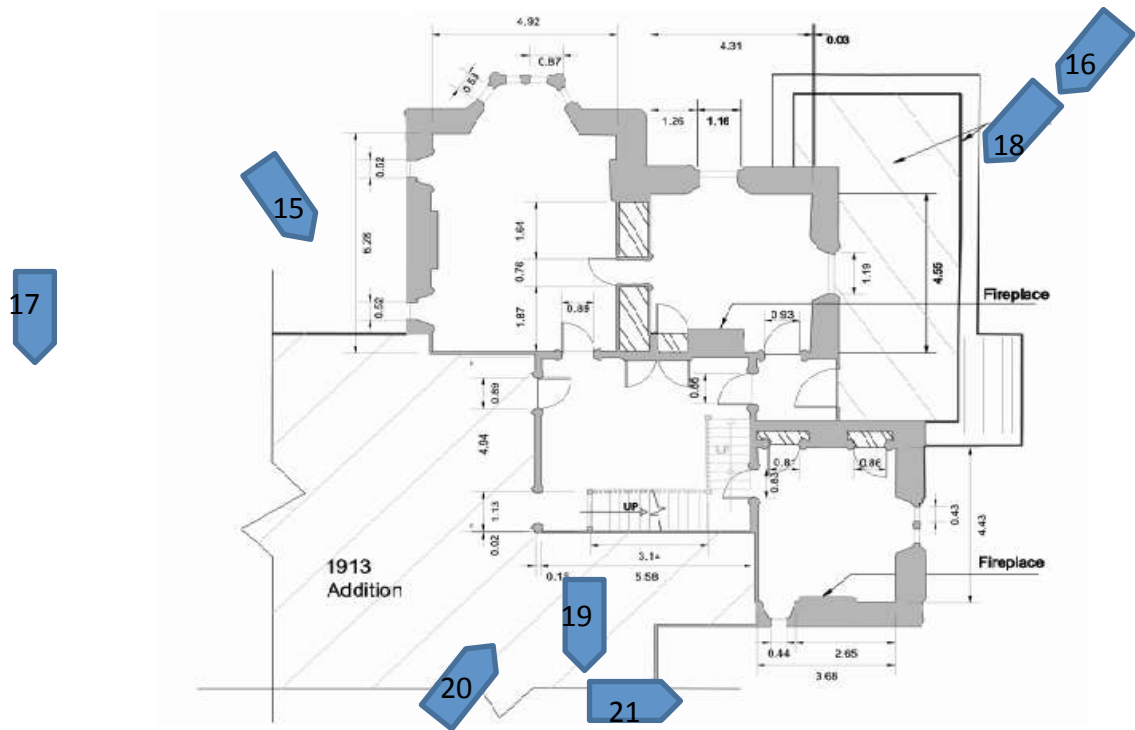
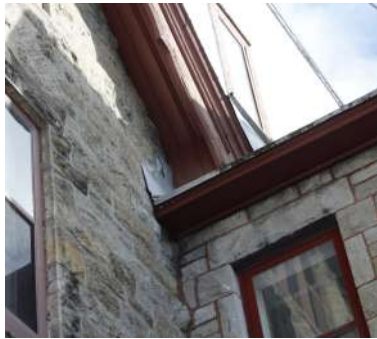
E15: Flashing between roof and masonry. Monastery of the Visitation of Holy Mary. Tom. Carleton University. 11-04-2019

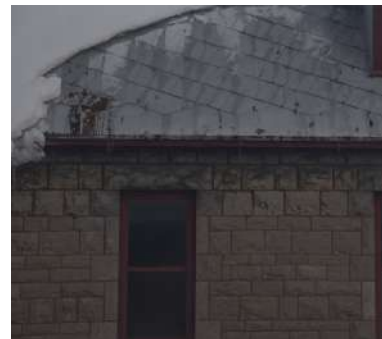
E17: Rusting on tin roof. Monastery of the Visitation of Holy Mary. Tom. Carleton University. 11-04-2019

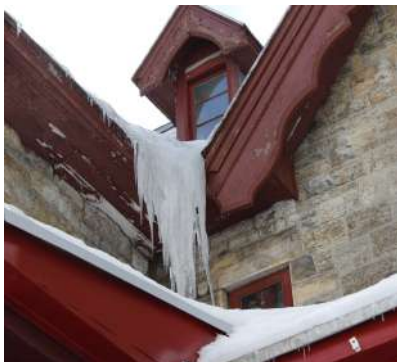
E18: Ice damming. Monastery of the Visitation of Holy Mary. Tom. Carleton University. 11-04-2019

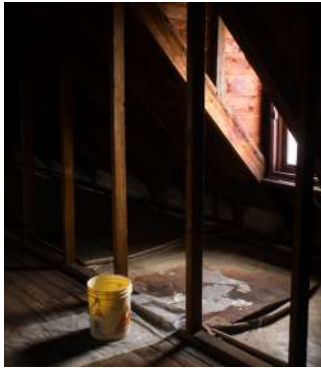
E21: Bucket for roof leakage.  
 Monastery of the Visitation  
 of Holy Mary. Renée.  
 Carleton University. 11-04-  
 2019

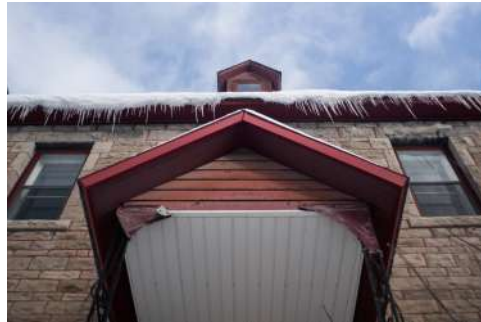
E22: Ice damming.  
 Monastery of the Visitation  
 of Holy Mary. Renée.  
 Carleton University. 11-04-  
 2019

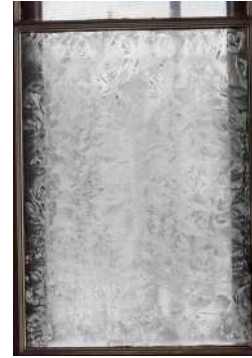
E25: Frosted window. Monastery of the Visitation of Holy Mary. Connor. Carleton University. 11-04-2019

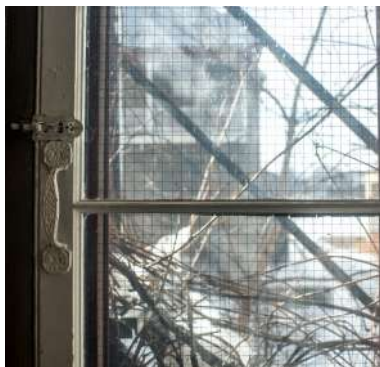
E26: Georgian Wire Glass. Monastery of the Visitation of Holy Mary. Renée. Carleton University. 11-04-2019

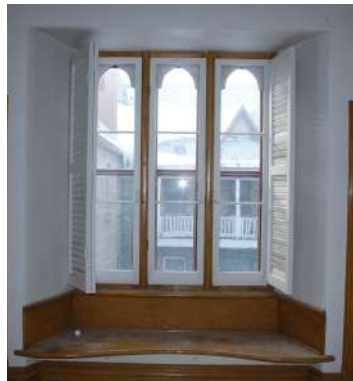
E27: Wooden windows in good condition. Monastery of the Visitation of Holy Mary. Jason. Carleton University. 11-04-2019

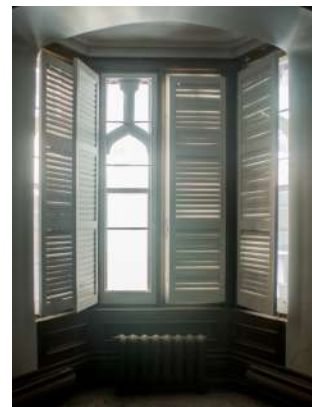
E28: Bay windows. Monastery of the Visitation of Holy Mary. Renée. Carleton University. 11-04-2019

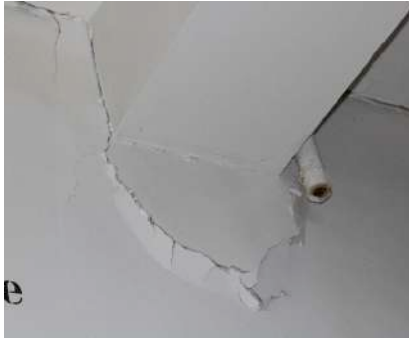
I1: Second Floor Beam Separation. Monastery of the Visitation of Holy Mary. Connor. Carleton University. 11-04-2019

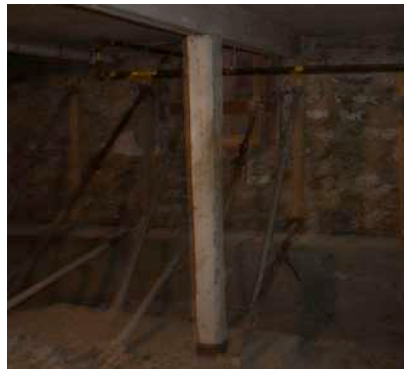
I5: Reinforcement of Stone Foundation. Monastery of the Visitation of Holy Mary. Jason. Carleton University. 11-04-2019

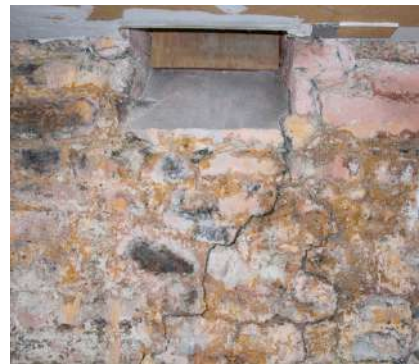
I6: Stone Foundation Cracks and Efflorescence. Monastery of the Visitation of Holy Mary. Jason. Carleton University. 11-04-2019

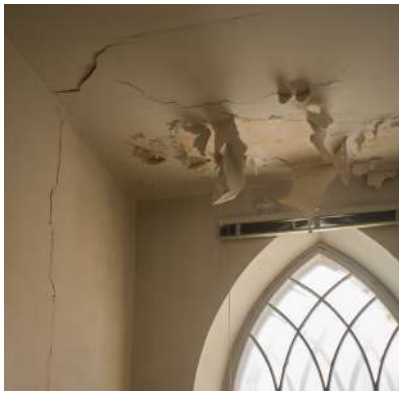
I7: Paint Peeling. Monastery of the Visitation of Holy Mary. Renée. Carleton University. 11-04-2019

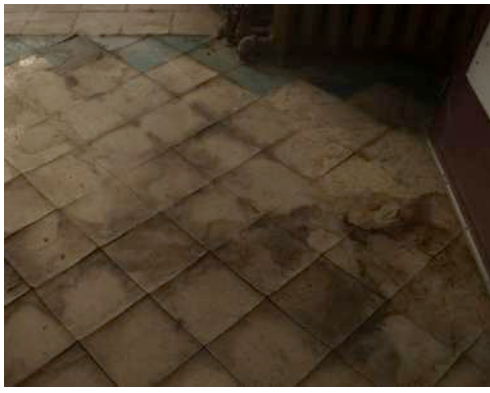
I8: Floor Tile Deterioration. Monastery of the Visitation of Holy Mary. Renée. Carleton University. 11-04-2019
